SMITHSONIAN INSTITUTION
BUREAU OF AMERICAN ETHNOLOGY
BULLETIN 121

ARCHEOLOGICAL REMAINS IN THE WHITEWATER DISTRICT EASTERN ARIZONA

PART I. HOUSE TYPES

By FRANK H. H. ROBERTS, JR.

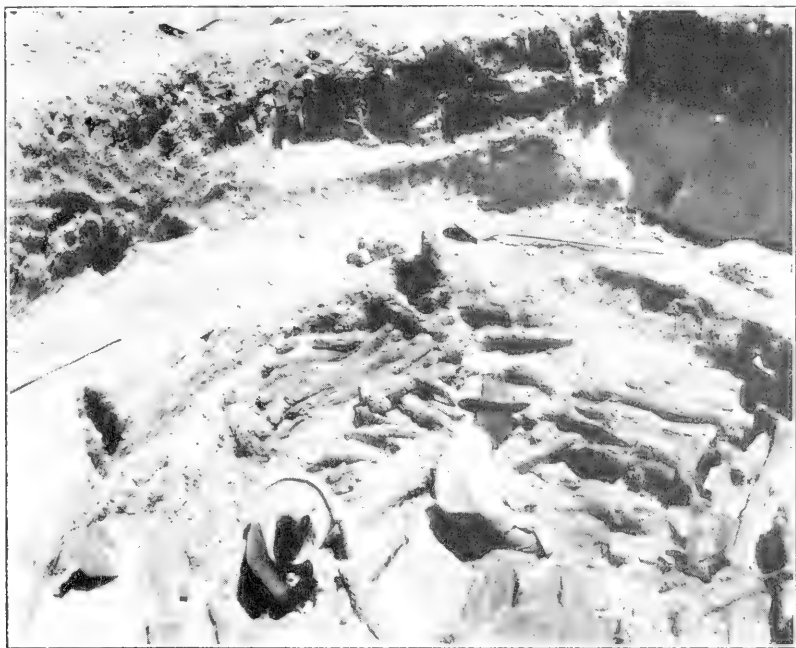
a. Burned roof timbers in p.t. of structure 15.

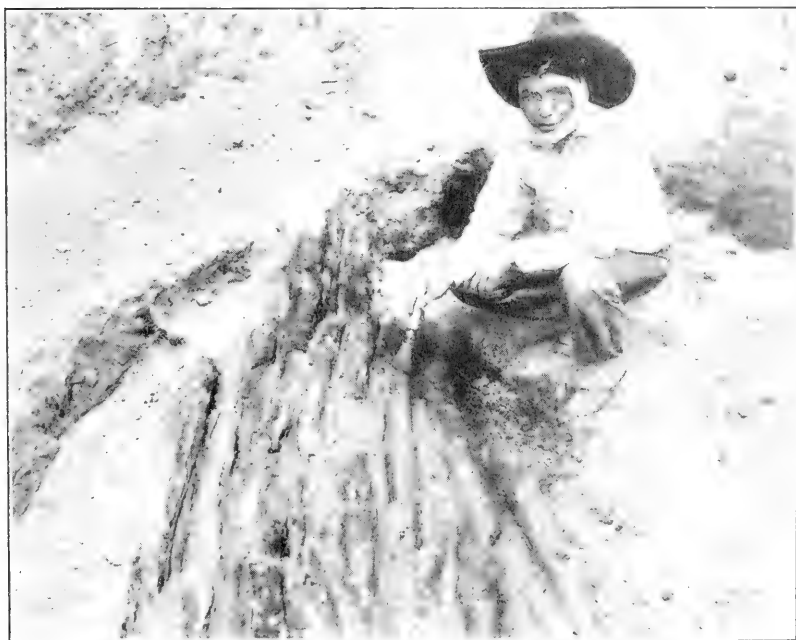
b. Series of slanting side poles for roof of structure 15.

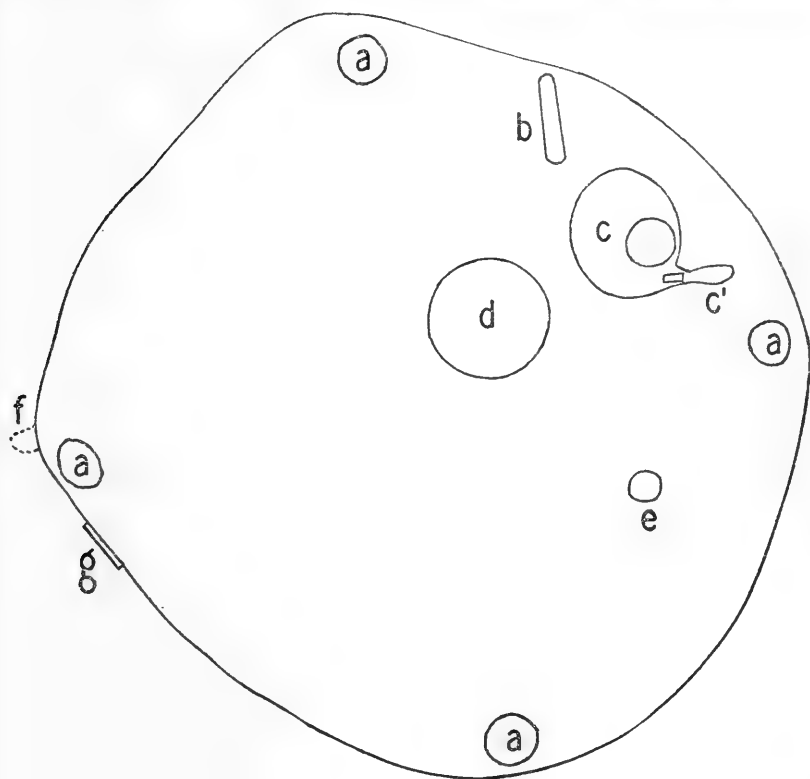
FIGURE 34.—Brush shelter. *a*, holes for support posts; *b*, stone in floor; *c*, storage pit in floor; *d*, fire pit; *e*, storage hole in floor; *f*, placement for roof brace; *g*, slab in wall.

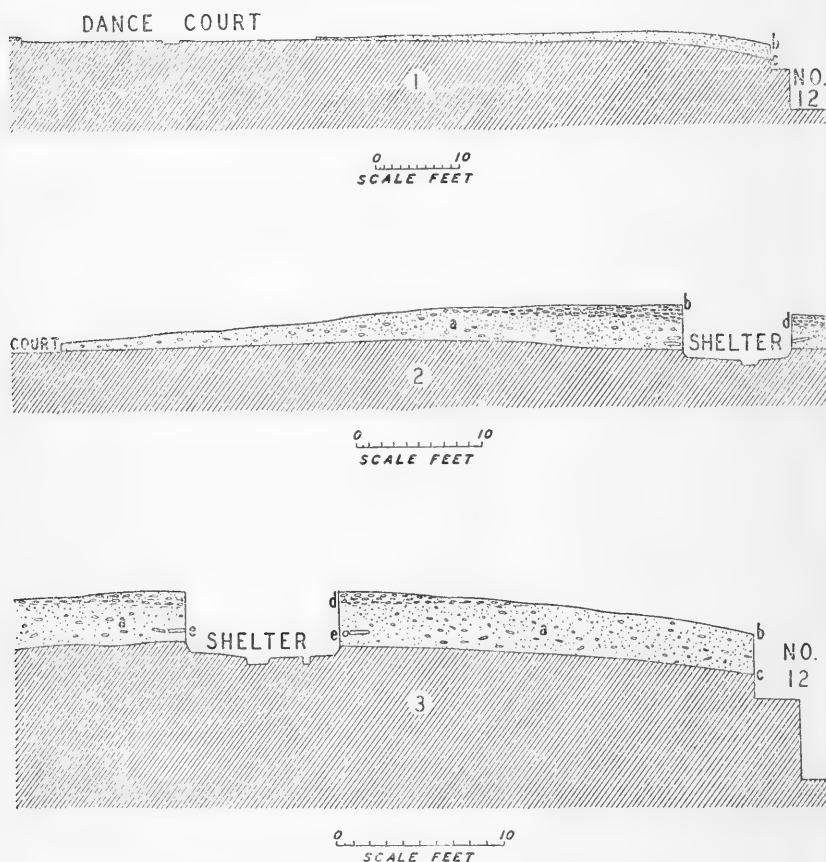
FIGURE 35.—Sections for structure 12, dance court and shelter.

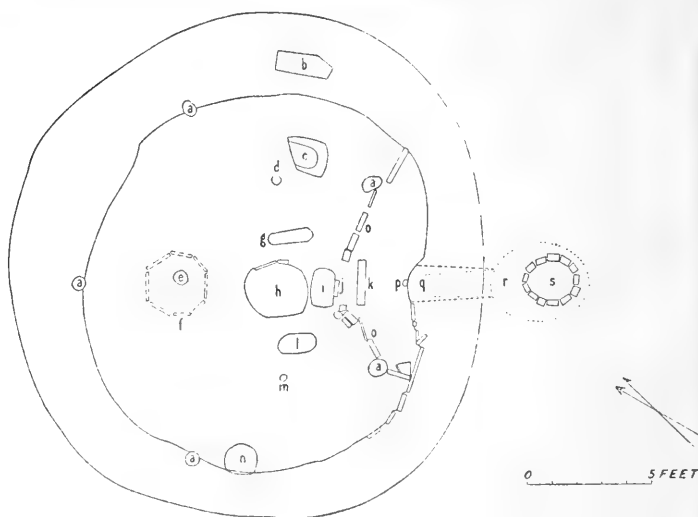
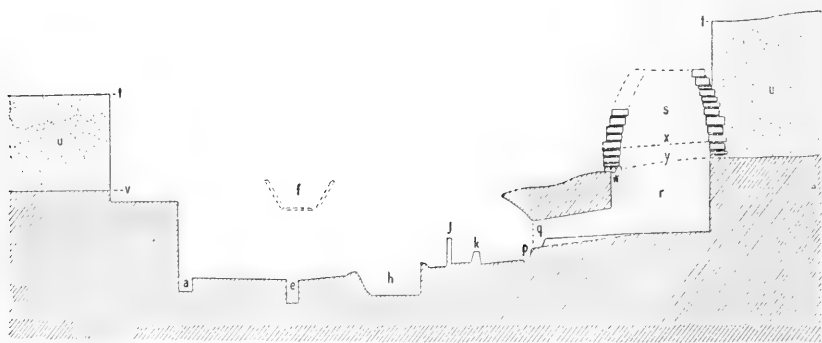
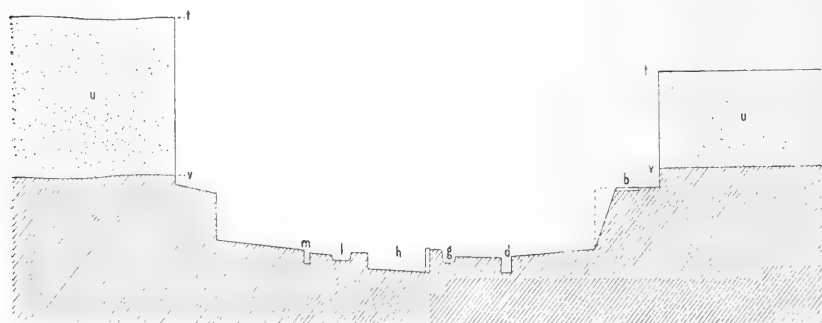
FIGURE 36.—Structure 15. *a*, holes for support posts; *b*, stone embedded in bench top; *c*, metate on floor; *d*, small storage hole; *e*, sipapu; *f*, fire pit; *g*, basin in floor; *h*, fire pit; *i*, ash pit; *j*, deflector; *k*, step and ladder brace; *l*, basin in floor; *m*, storage hole in floor; *n*, storage basin; *o*, compartment wall; *p*, hole for post to brace cover stone; *q*, ventilator opening; *r*, base of ventilator shaft; *s*, ventilator opening on ground; *t*, present surface; *u*, sand accumulation; *v*, original surface; *w*, wooden support for masonry; *x*, floor in granary; *y*, surface of accumulated material in shaft.

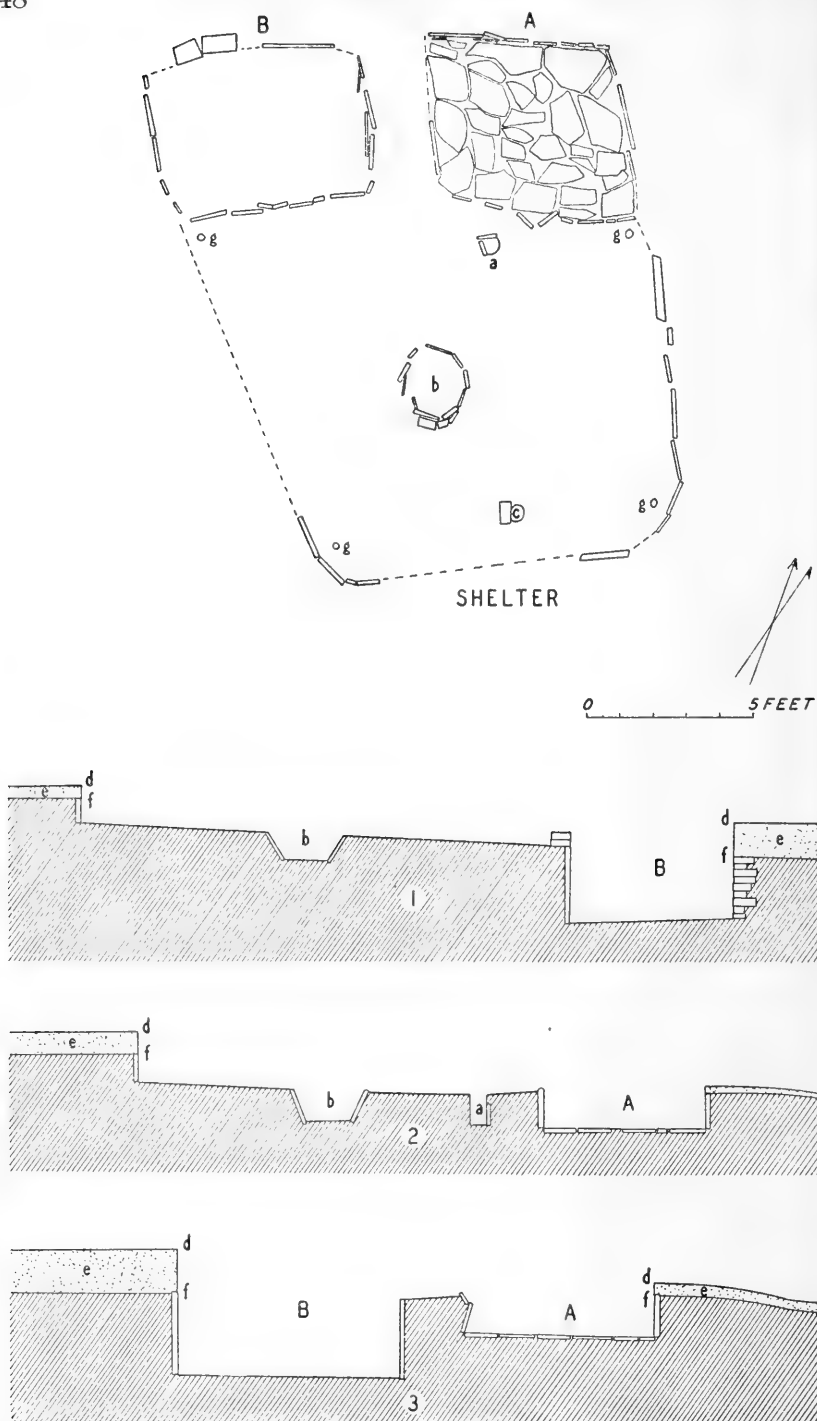
FIGURE 38.—Granaries A and B and shelter in No. 15 group. *a*, hole for support post; *b*, fire pit; *c*, hole for support post; *d*, present surface; *e*, sand fill; *f*, original surface; *g*, holes for corner supports for arbor.

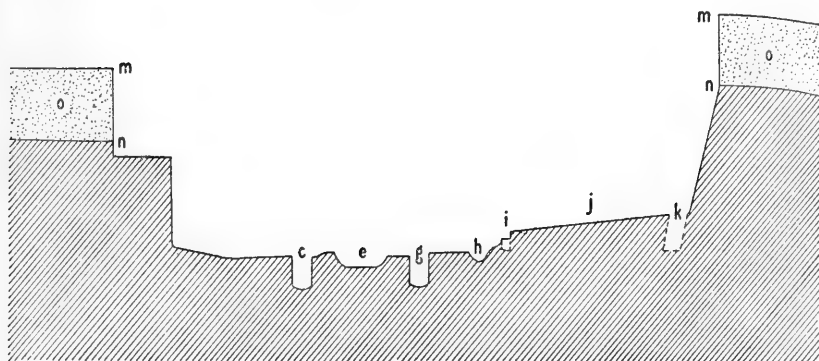
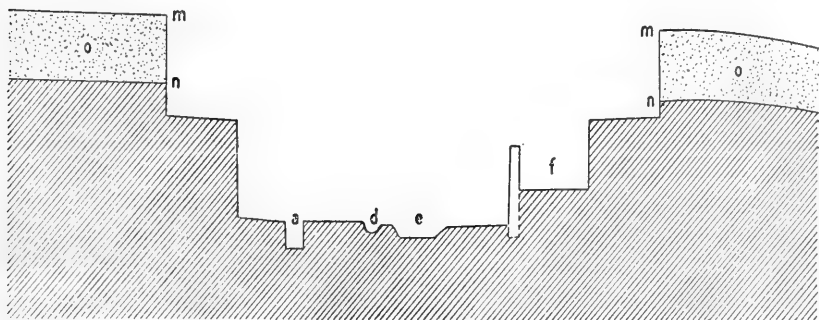
FIGURE 40.—Structure 10. *a*, holes for main roof supports; *b*, small storage hole; *c*, sipapu; *d*, pot rest; *e*, fire pit; *f*, storage bin; *g*, groove for compartment wall; *h*, basin in floor; *i*, sill in passage opening; *j*, passage; *k*, holes for ladder poles; *l*, placements for side poles; *m*, present surface; *n*, old surface; *o*, sand fill.

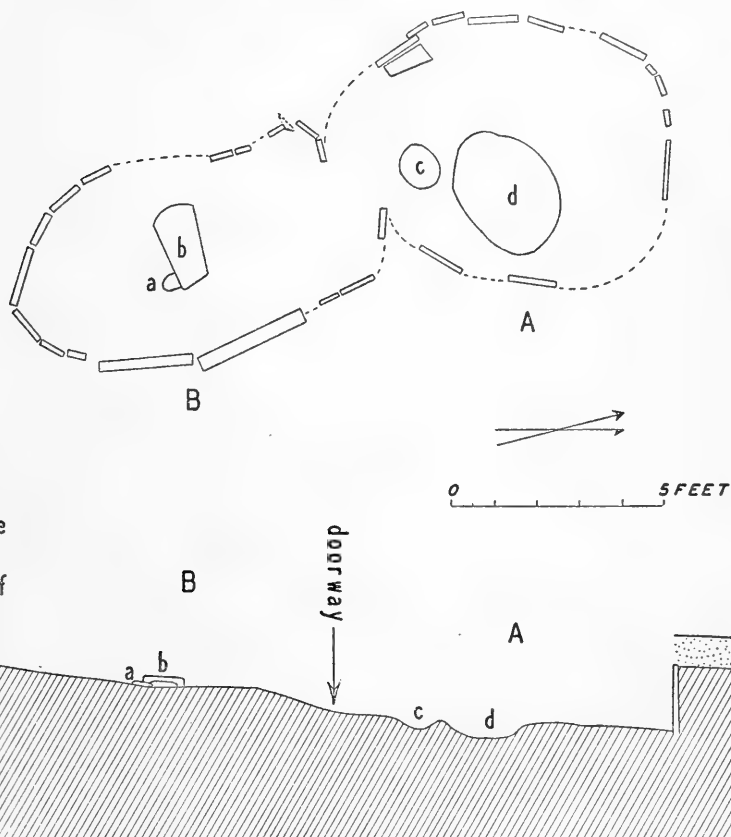
FIGURE 41.—Granaries A and B of the No. 16 group. *a*, mano or hand milling stone; *b*, metate stone; *c*, fire pit; *d*, storage basin; *e*, present surface; *f*, original ground level.

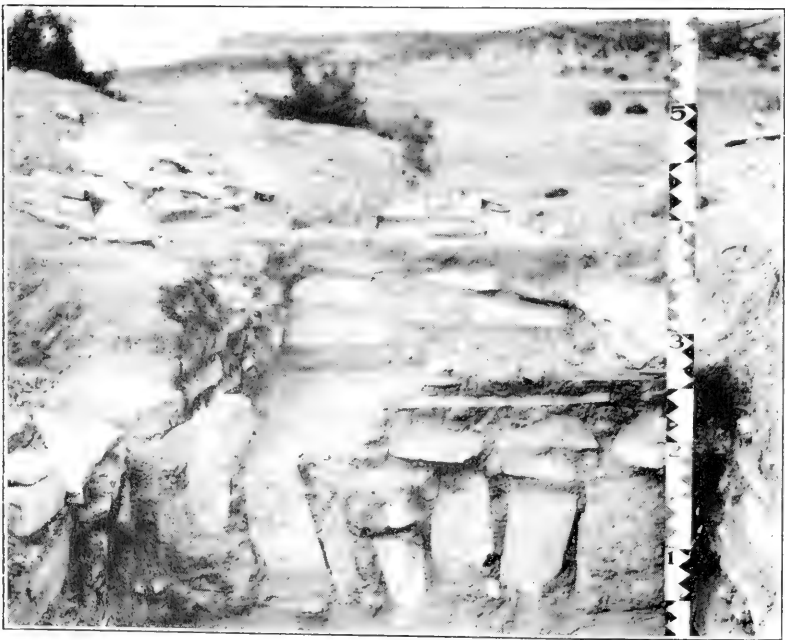
Wall construction in second unit.

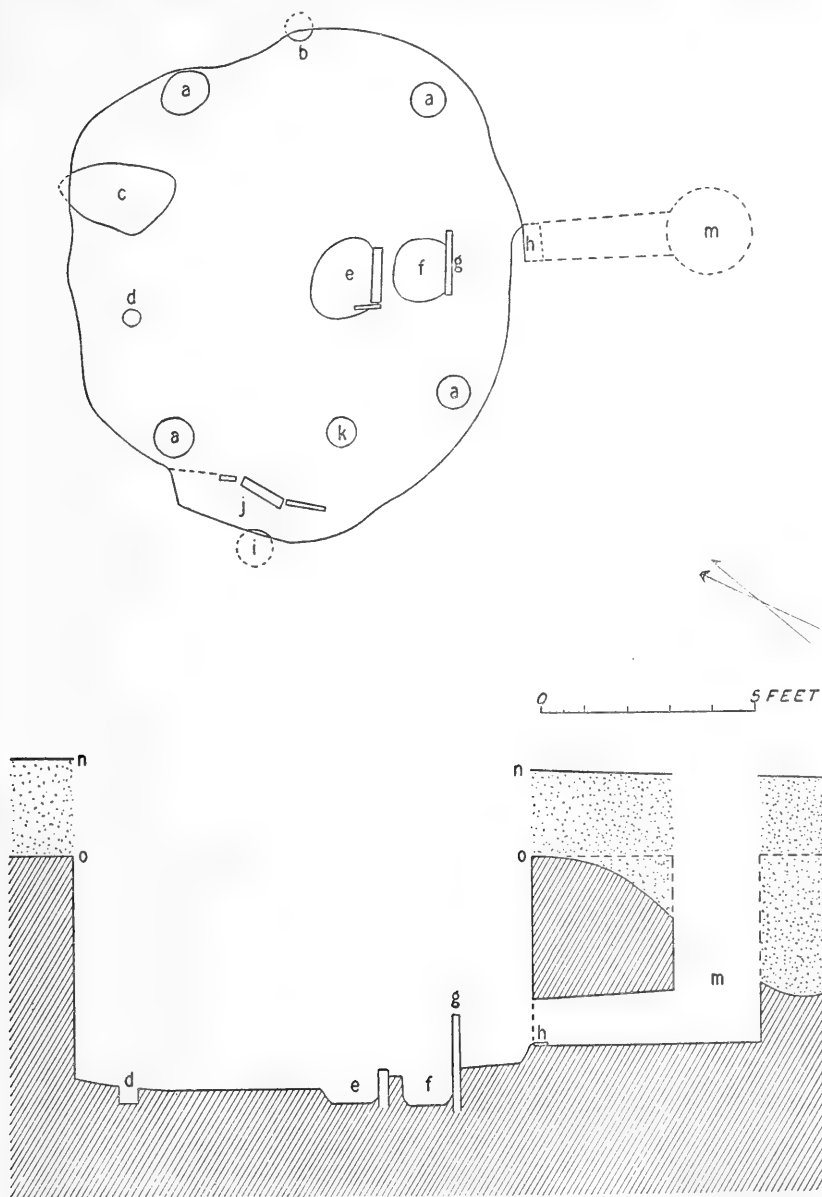
FIGURE 42.—Structure 17. *a*, holes for support posts; *b*, subwall pocket; *c*, storage pit; *d*, sipapu; *e*, fire pit; *f*, basin for ashes and ladder; *g*, deflector; *h*, sill in ventilator opening; *i*, subwall pocket; *j*, storage bin; *k*, pot rest; *m*, ventilator shaft; *n*, present ground level; *o*, original surface.

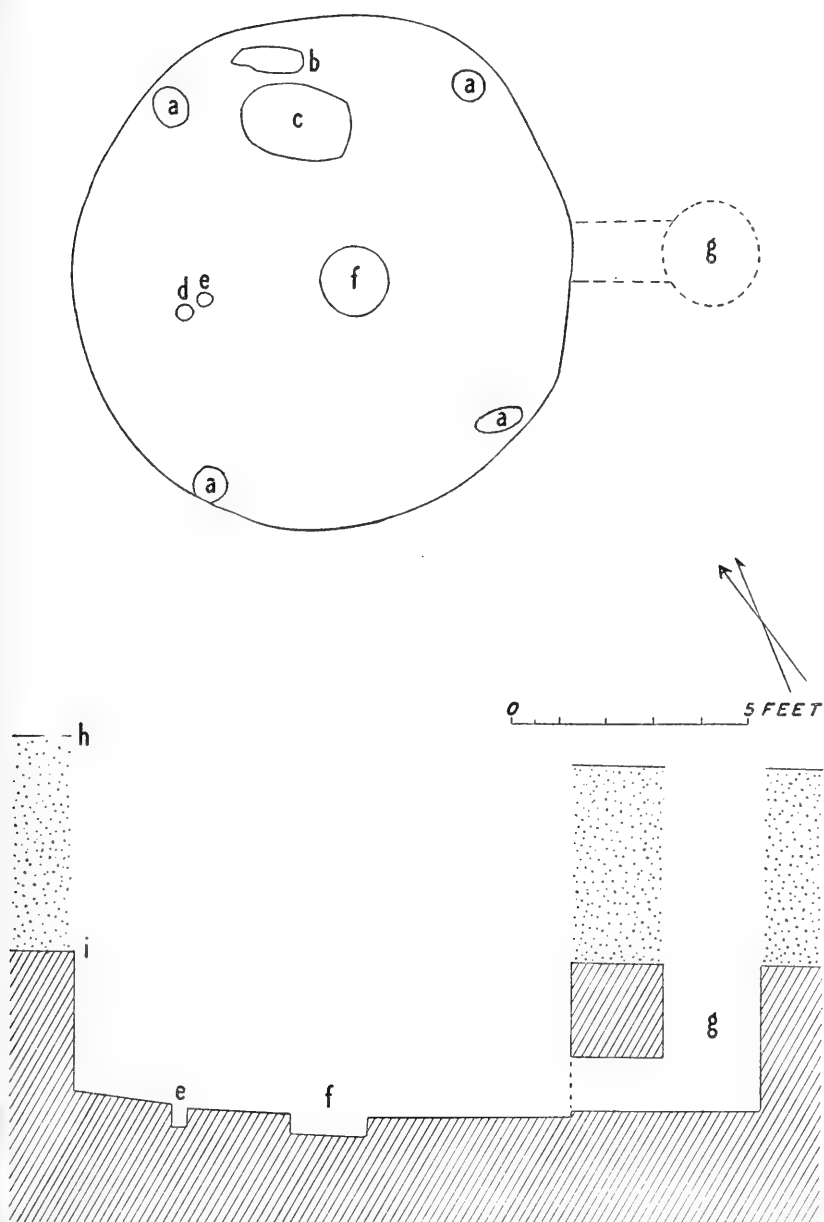
FIGURE 43.—Structure 18. *a*, holes for roof supports; *b*, storage pit in floor; *c*, storage basin; *d* and *e*, sipapus; *f*, fire pit; *g*, ventilator shaft; *h*, present surface; *i*, old ground level.

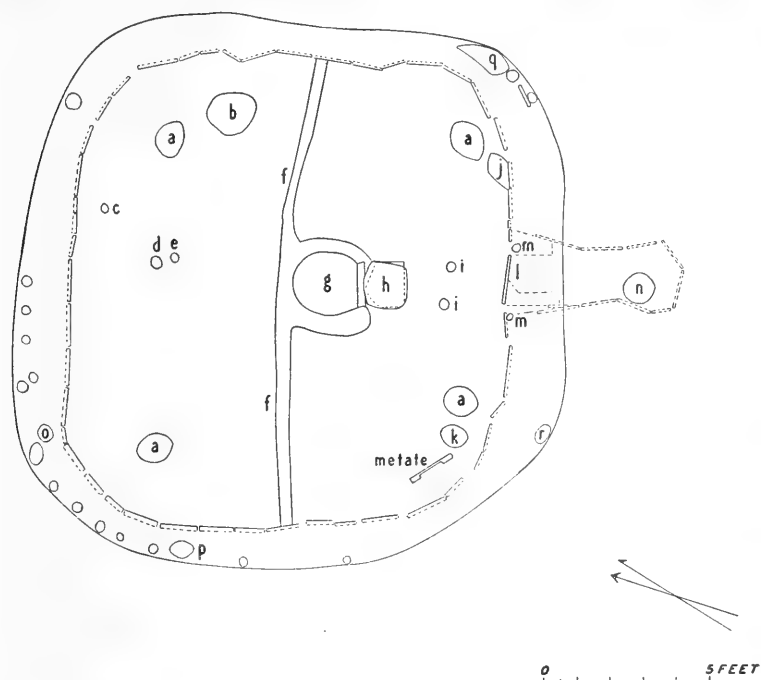
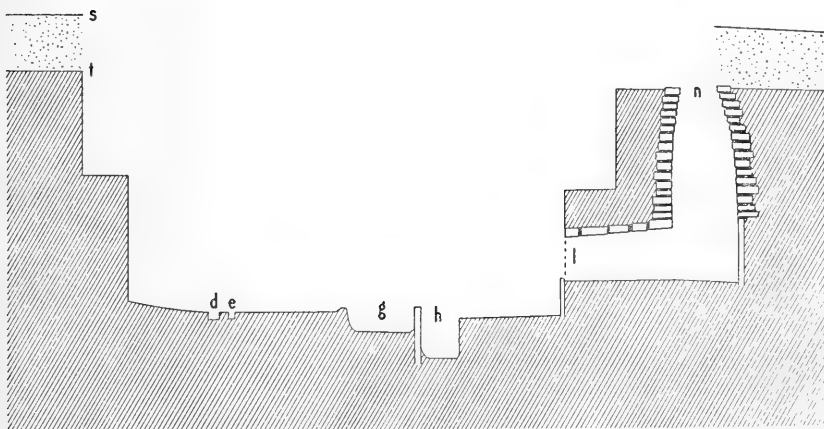
FIGURE 45.—Kiva A. *a*, holes for roof supports; *b*, storage pit; *c*, storage hole; *d* and *e*, sipapus; *f*, plaster ridge on floor; *g*, fire pit; *h*, old ladder pit; *i*, ladder pole depressions; *j*, storage pocket; *k*, pot rest or storage pocket; *l*, ventilator aperture; *m*, poles reinforcing ventilator opening; *n*, ventilator shaft; *o*, slanting timber placements; *p*, *q*, *r*, storage pockets on bench top; *s*, present surface; *t*, old ground level.

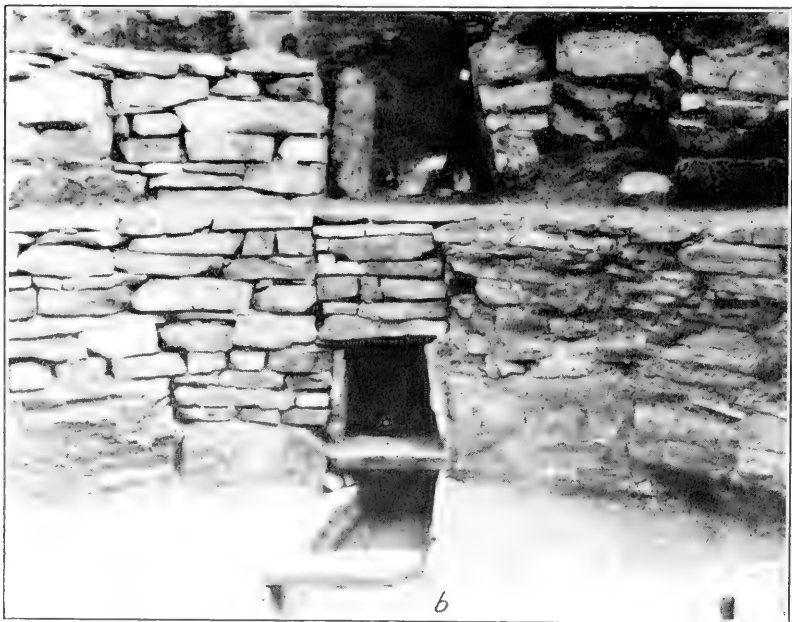
b. Ventilator openings in Kiva B.

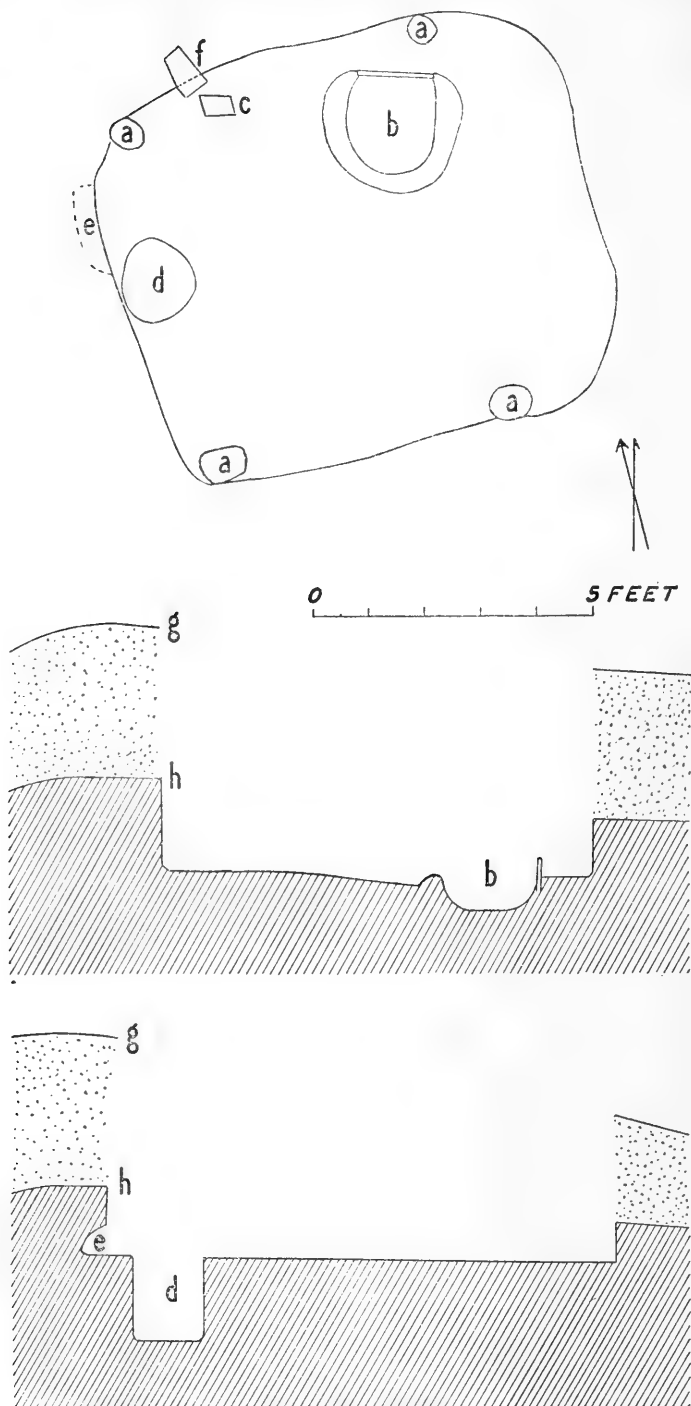
FIGURE 46.—Brush shelter. *a*, holes for roof supports; *b*, fire pit; *c*, stone step; *d*, storage pit in floor; *e*, subwall pocket; *f*, stone tread; *g*, present surface; *h*, old ground level.

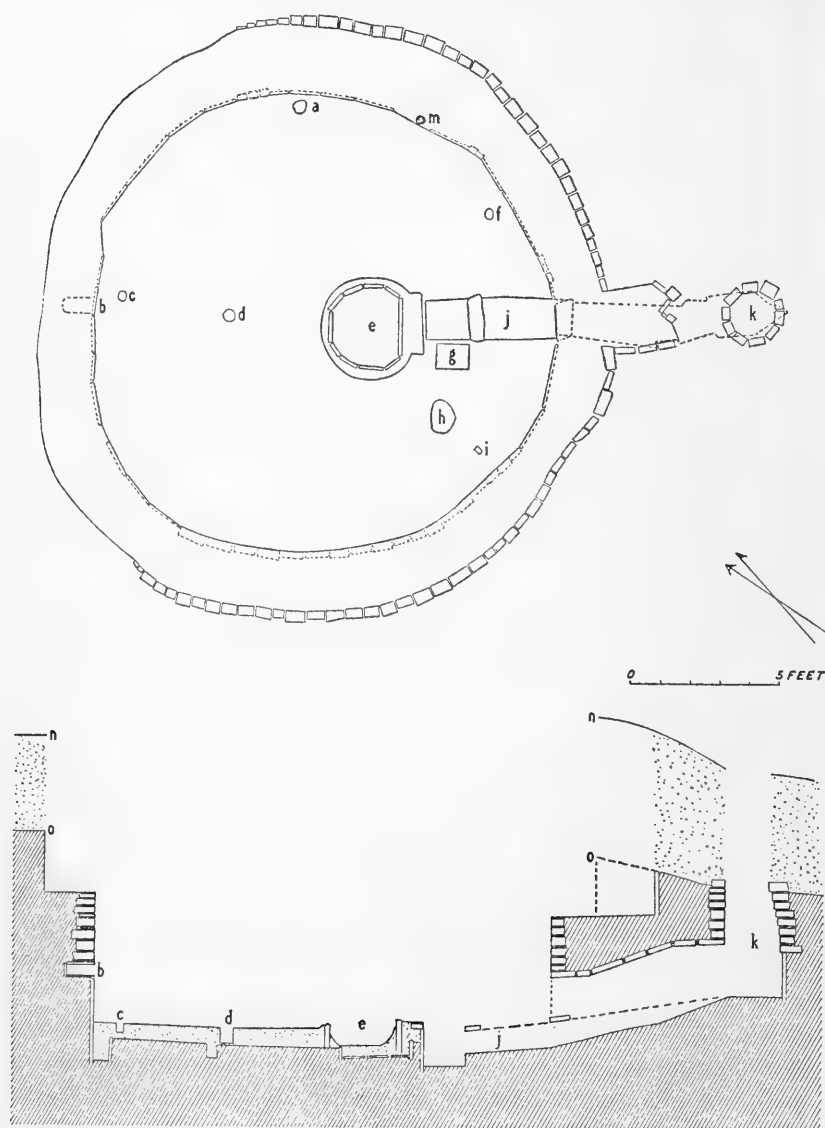
FIGURE 47.—Kiva B, upper floor level. *a*, storage hole in floor; *b*, Katsina niche; *c*, storage hole in floor; *d*, sipapu; *e*, fire pit; *f*, storage hole; *g*, ash pit; *h*, stone in floor; *i*, stone in floor; *j*, subfloor ventilator trench; *k*, ventilator shaft; *m*, post incorporated in bench; *n*, present ground level; *o*, original surface.

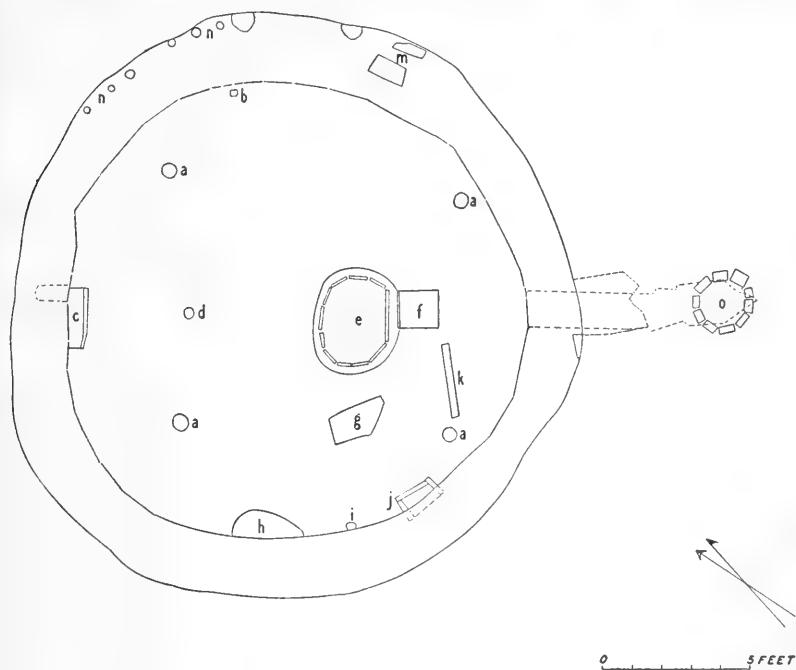
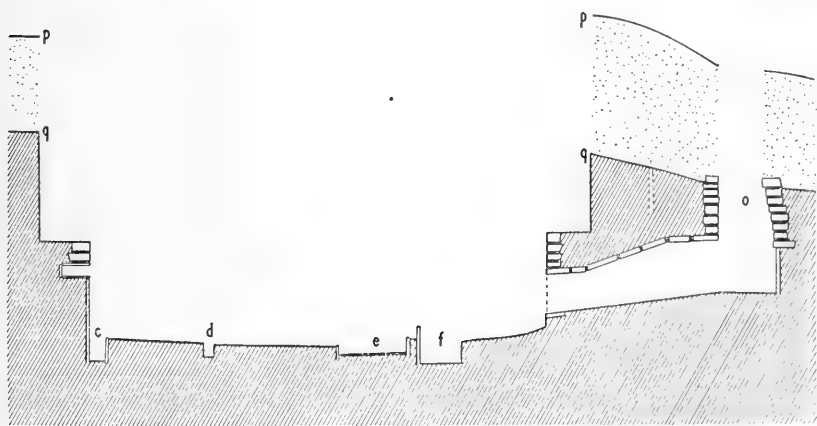
FIGURE 48.—Kiva B, original floor level. *a*, holes for main roof posts; *b*, stone in floor; *c*, storage box; *d*, sipapu; *e*, fire pit; *f*, ladder box; *g*, stone embedded in floor; *h*, storage pit; *i*, storage hole; *j*, subwall storage box; *k*, stone in floor; *m*, stones embedded on bench top; *n*, holes for slanting side poles; *o*, ventilator shaft; *p*, present ground level; *q*, original surface.

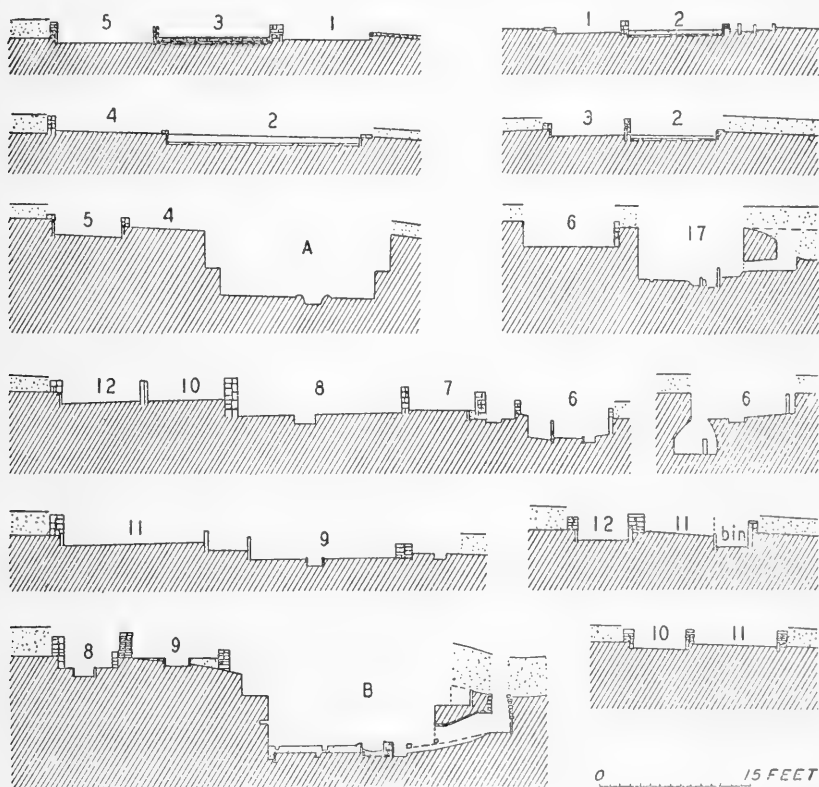
FIGURE 49.—Sections in first and second units.

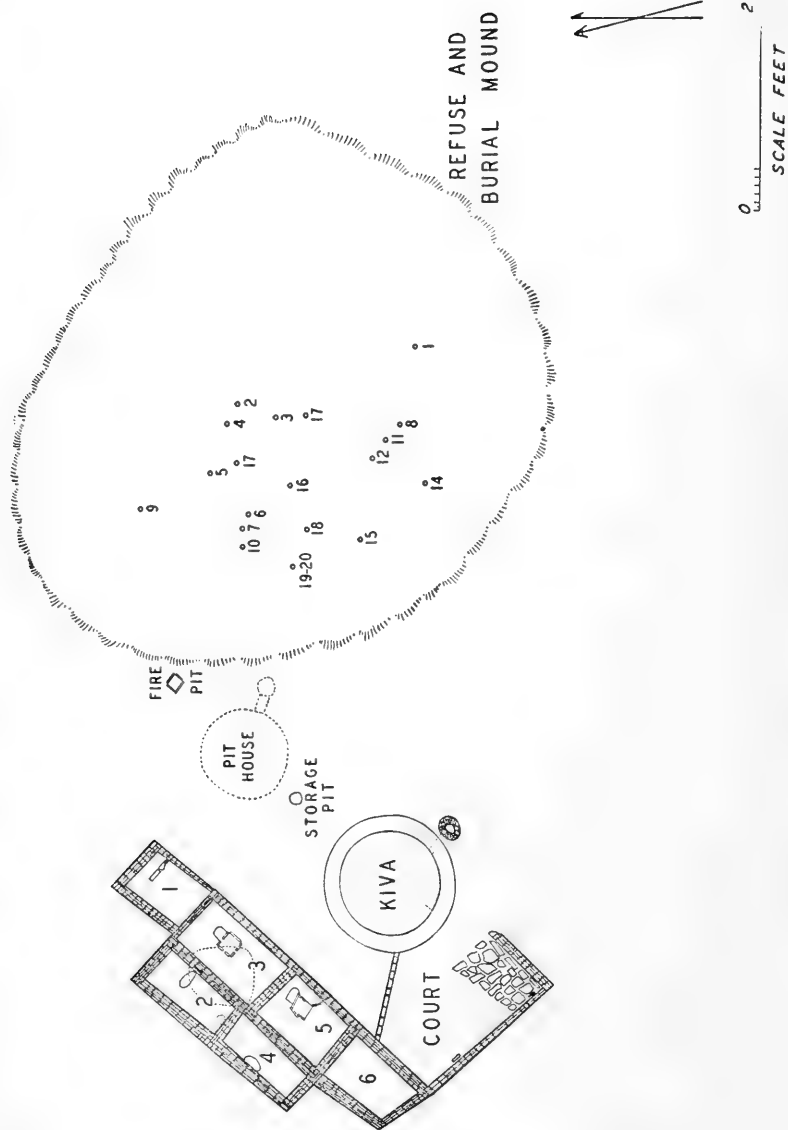
FIGURE 50.—Plan of unit No. 3. Dotted lines indicate location of pit structure 18. Numbered dots show positions of burials.

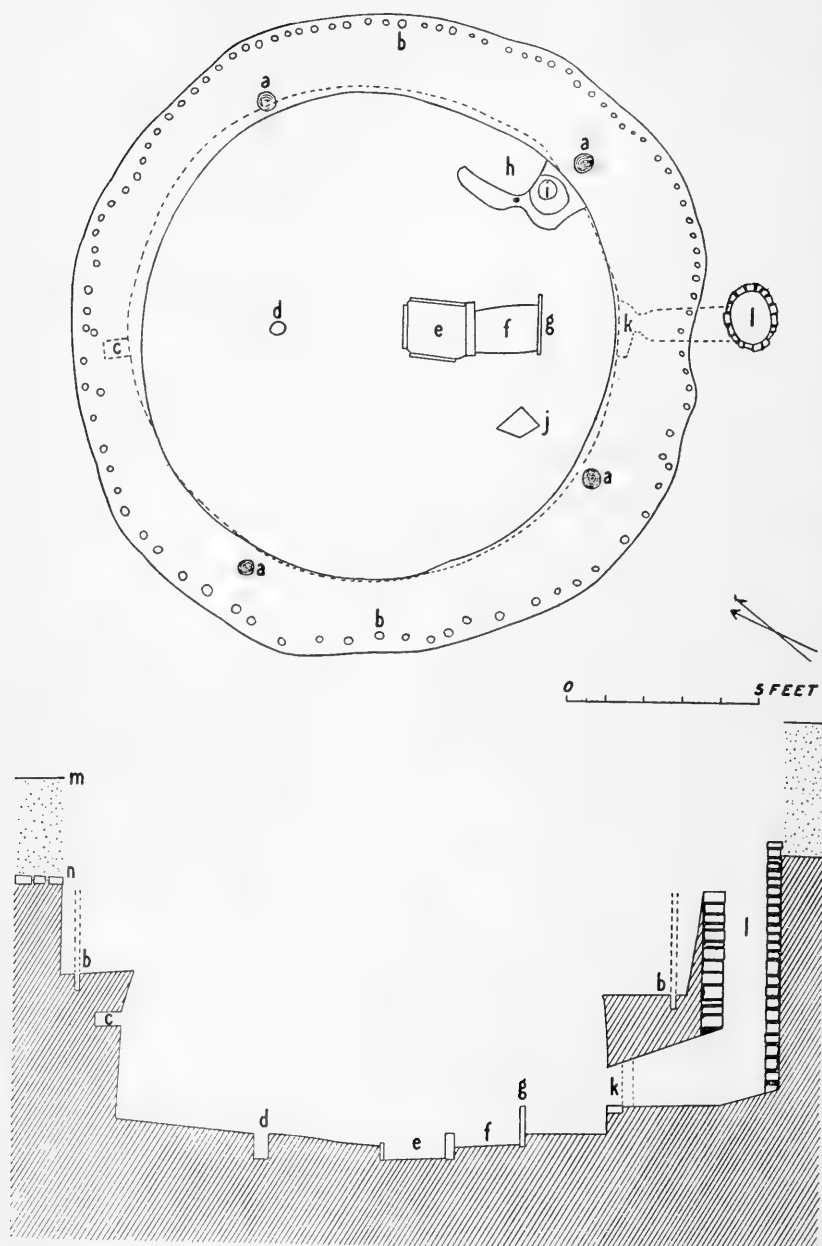
FIGURE 51.—Kiva for unit No. 3. *a*, posts incorporated in bench to reinforce wall; *b*, holes for poles forming wainscoting; *c*, Katsina niche; *d*, sipapu; *e*, fire pit; *f*, ash pit and ladder box; *g*, deflector; *h*, shallow basin in floor; *i*, small circular basin with stone bottom; *j*, stone embedded in floor; *k*, ventilator opening; *l*, ventilator shaft; *m*, present surface; *n*, old ground level.

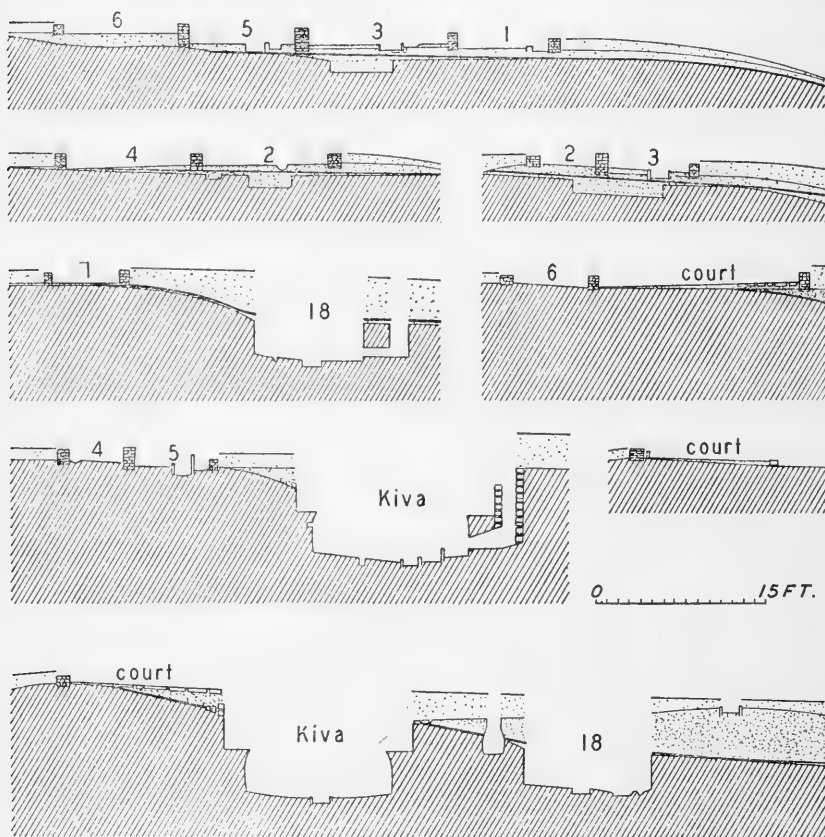
FIGURE 52.—Sections in third unit. Heavy line passing through fill indicates layer of red earth separating occupation level of pit structure and that of subsequent unit.

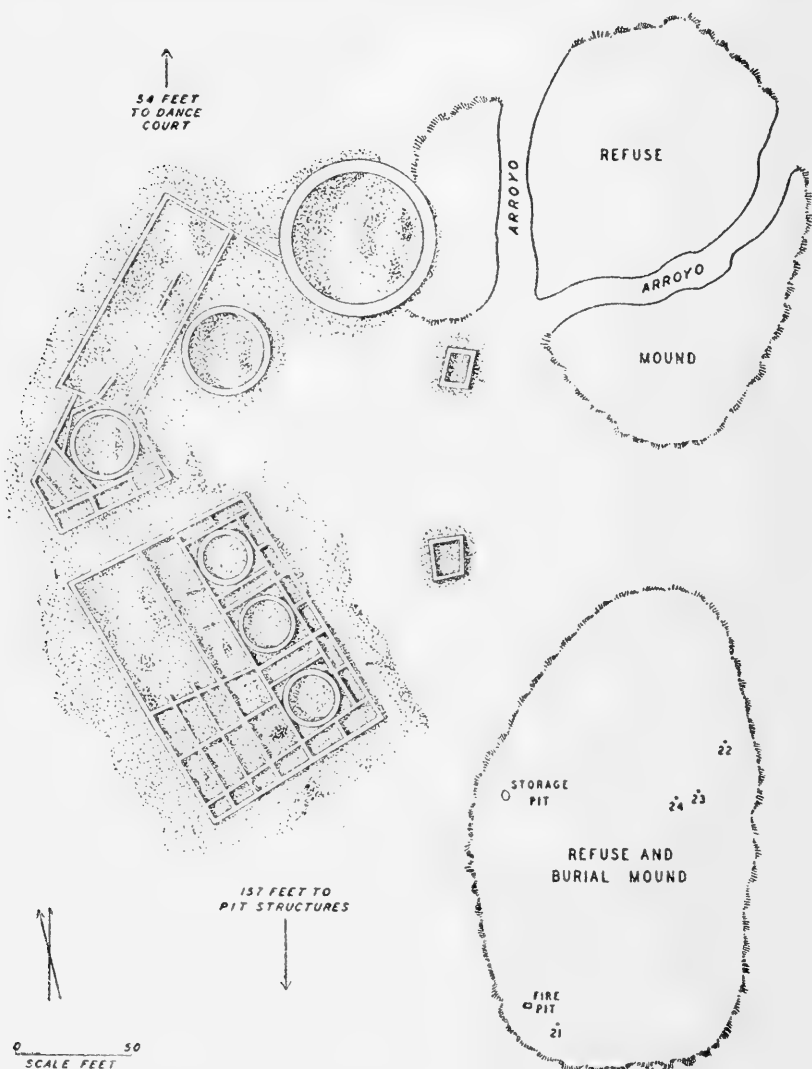
FIGURE 53.—Plan of large ruins of Great Pueblo period.
